Ultra-Hard Tungsten Carbide Based Coatings

WESTERN PROCESS CONTROLS PTY

Case Study

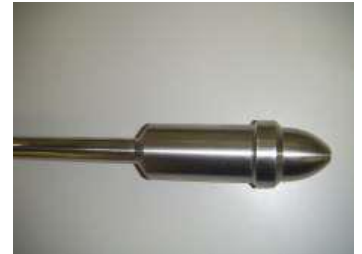
New plug

The fourth design was a one piece 316SST/COCRA (Alloy 6) plug stem. This lasted between six and eight weeks before erosion caused total failure of the AA control valve. The average repair cost after a plug failure was US\$12,000.

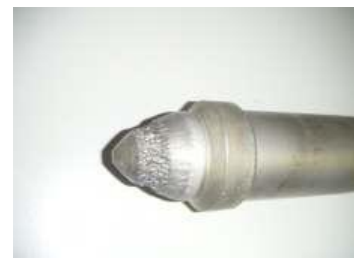
Short term wear

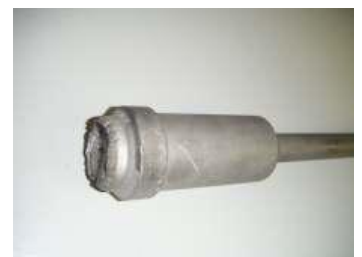
Complete failure
